LEVEL 2

Your survey and valuation report

9 St Marks Road
Bromley
BR2 9HG

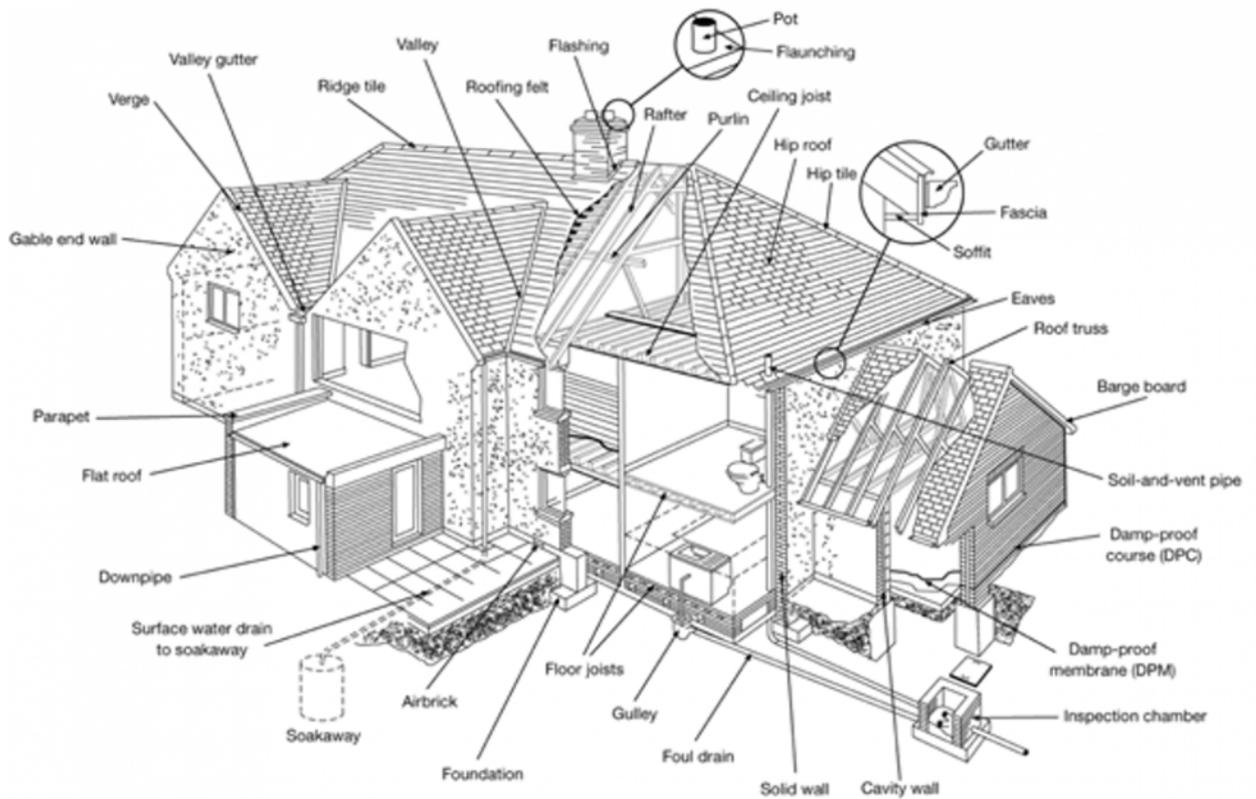
Typical house diagram

This diagram illustrates where you may find some of the building elements referred to in the report.
