LEVEL 3

Your survey report

9 ST MARKS ROAD
BROMLEY
BR2 9HG

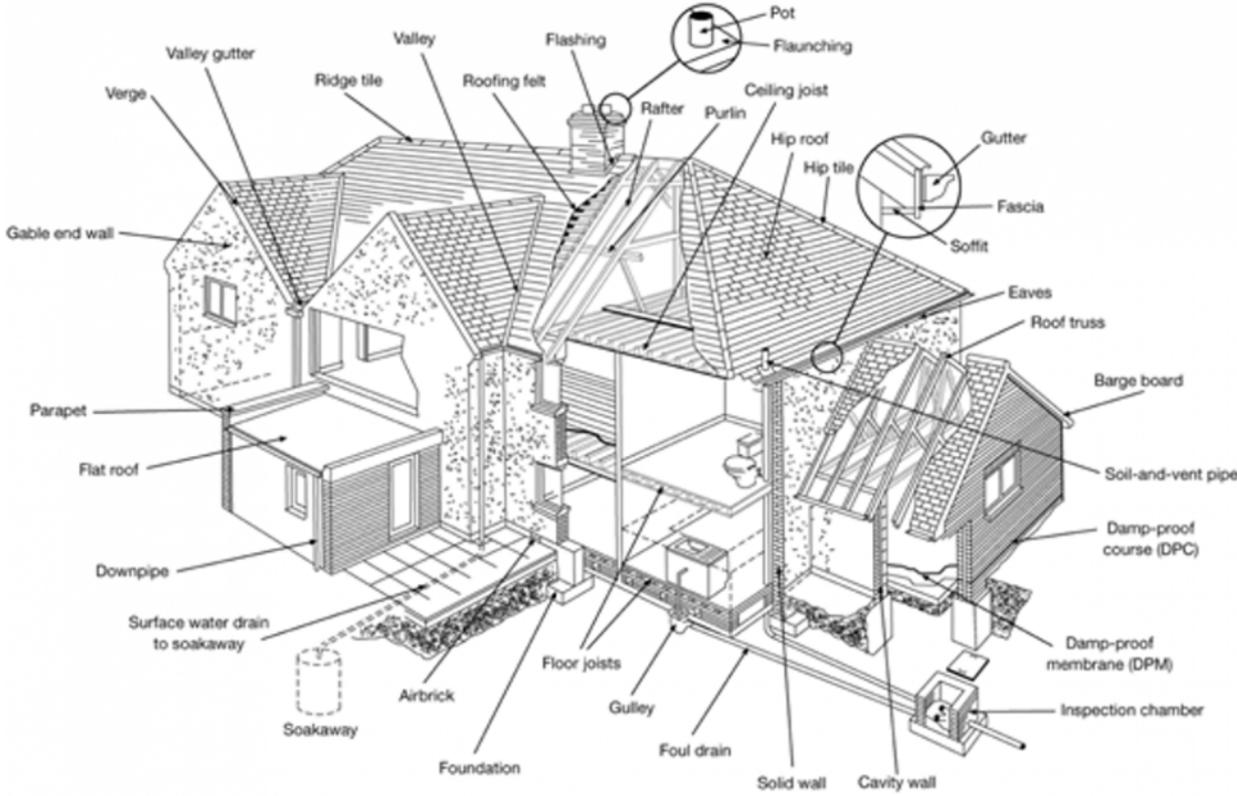
Typical house diagram

This diagram illustrates where you may find some of the building elements referred to in the report.
